## Tadcaster Bridge Stabilisation

Tadcaster, North Yorkshire

### The project

The stabilisation of the flood affected Tadcaster Bridge to allow the safe repair and reopening of the bridge after the collapse.

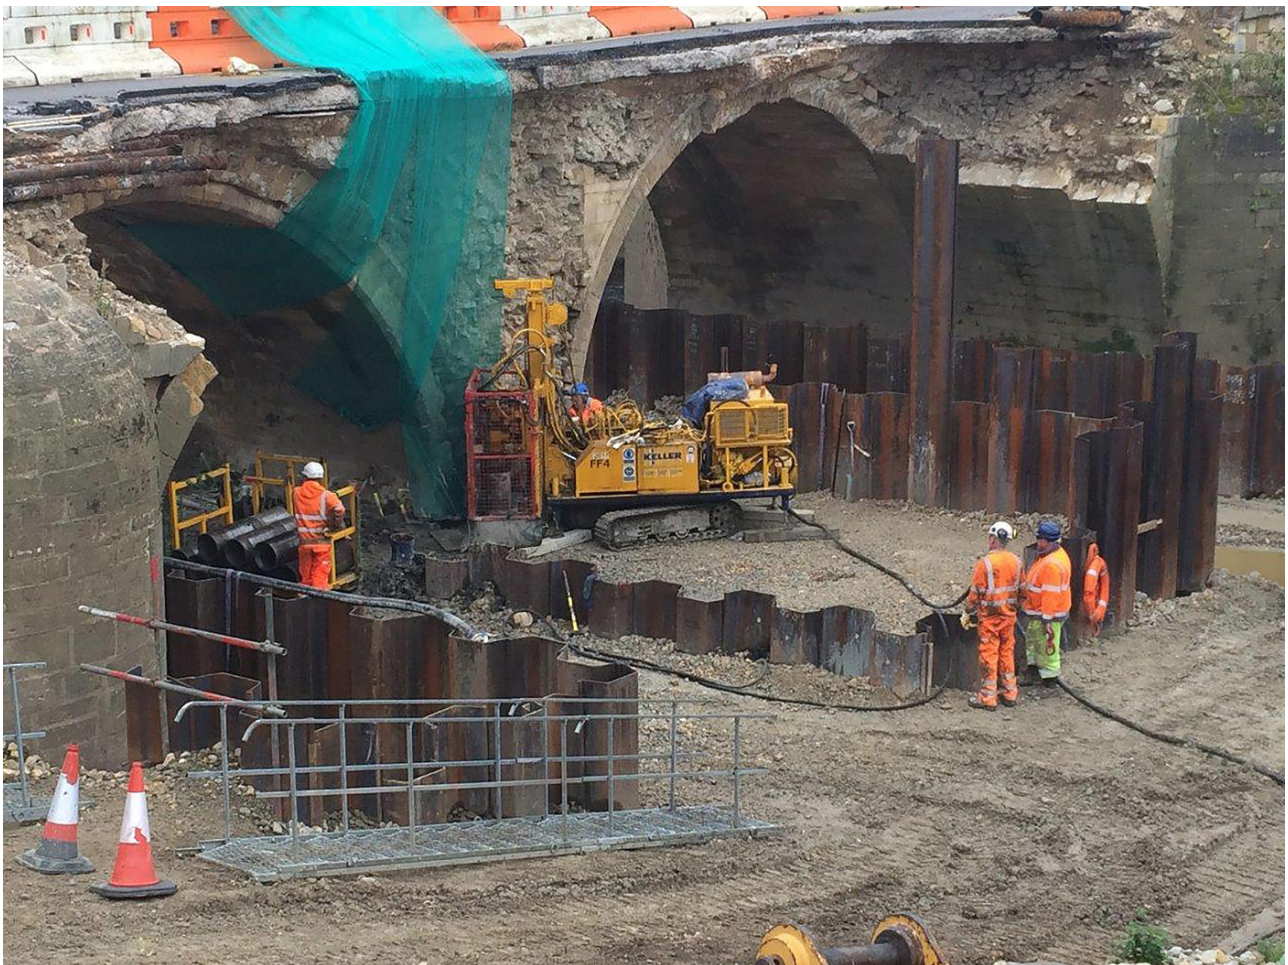
Heavy rain over Christmas 2015 led to the partial collapse of Tadcaster Bridge which connected the two halves of the town.

The installation of 12 inclined piles on pier 5 (the one that suffered the most damage) and six vertical ones between the inclined ones. We also installed 35 piles to construct the secant walls for the cofferdam along with 20 bearing piles for new pier bases. We were then asked to install a further 12 inclined Pali Radice piles to the existing Pier 6 from bridge deck level through the pier to compensate for any differential settlement that could occur once pier 5 was stabilised. Works were undertaken using two crews working 12-hour day and night shifts over two visits to site, ensuring these additional works were also complete in time for the bridge opening.
