## **Jackfield Stabilisation Project**

Jackfield, Shropshire

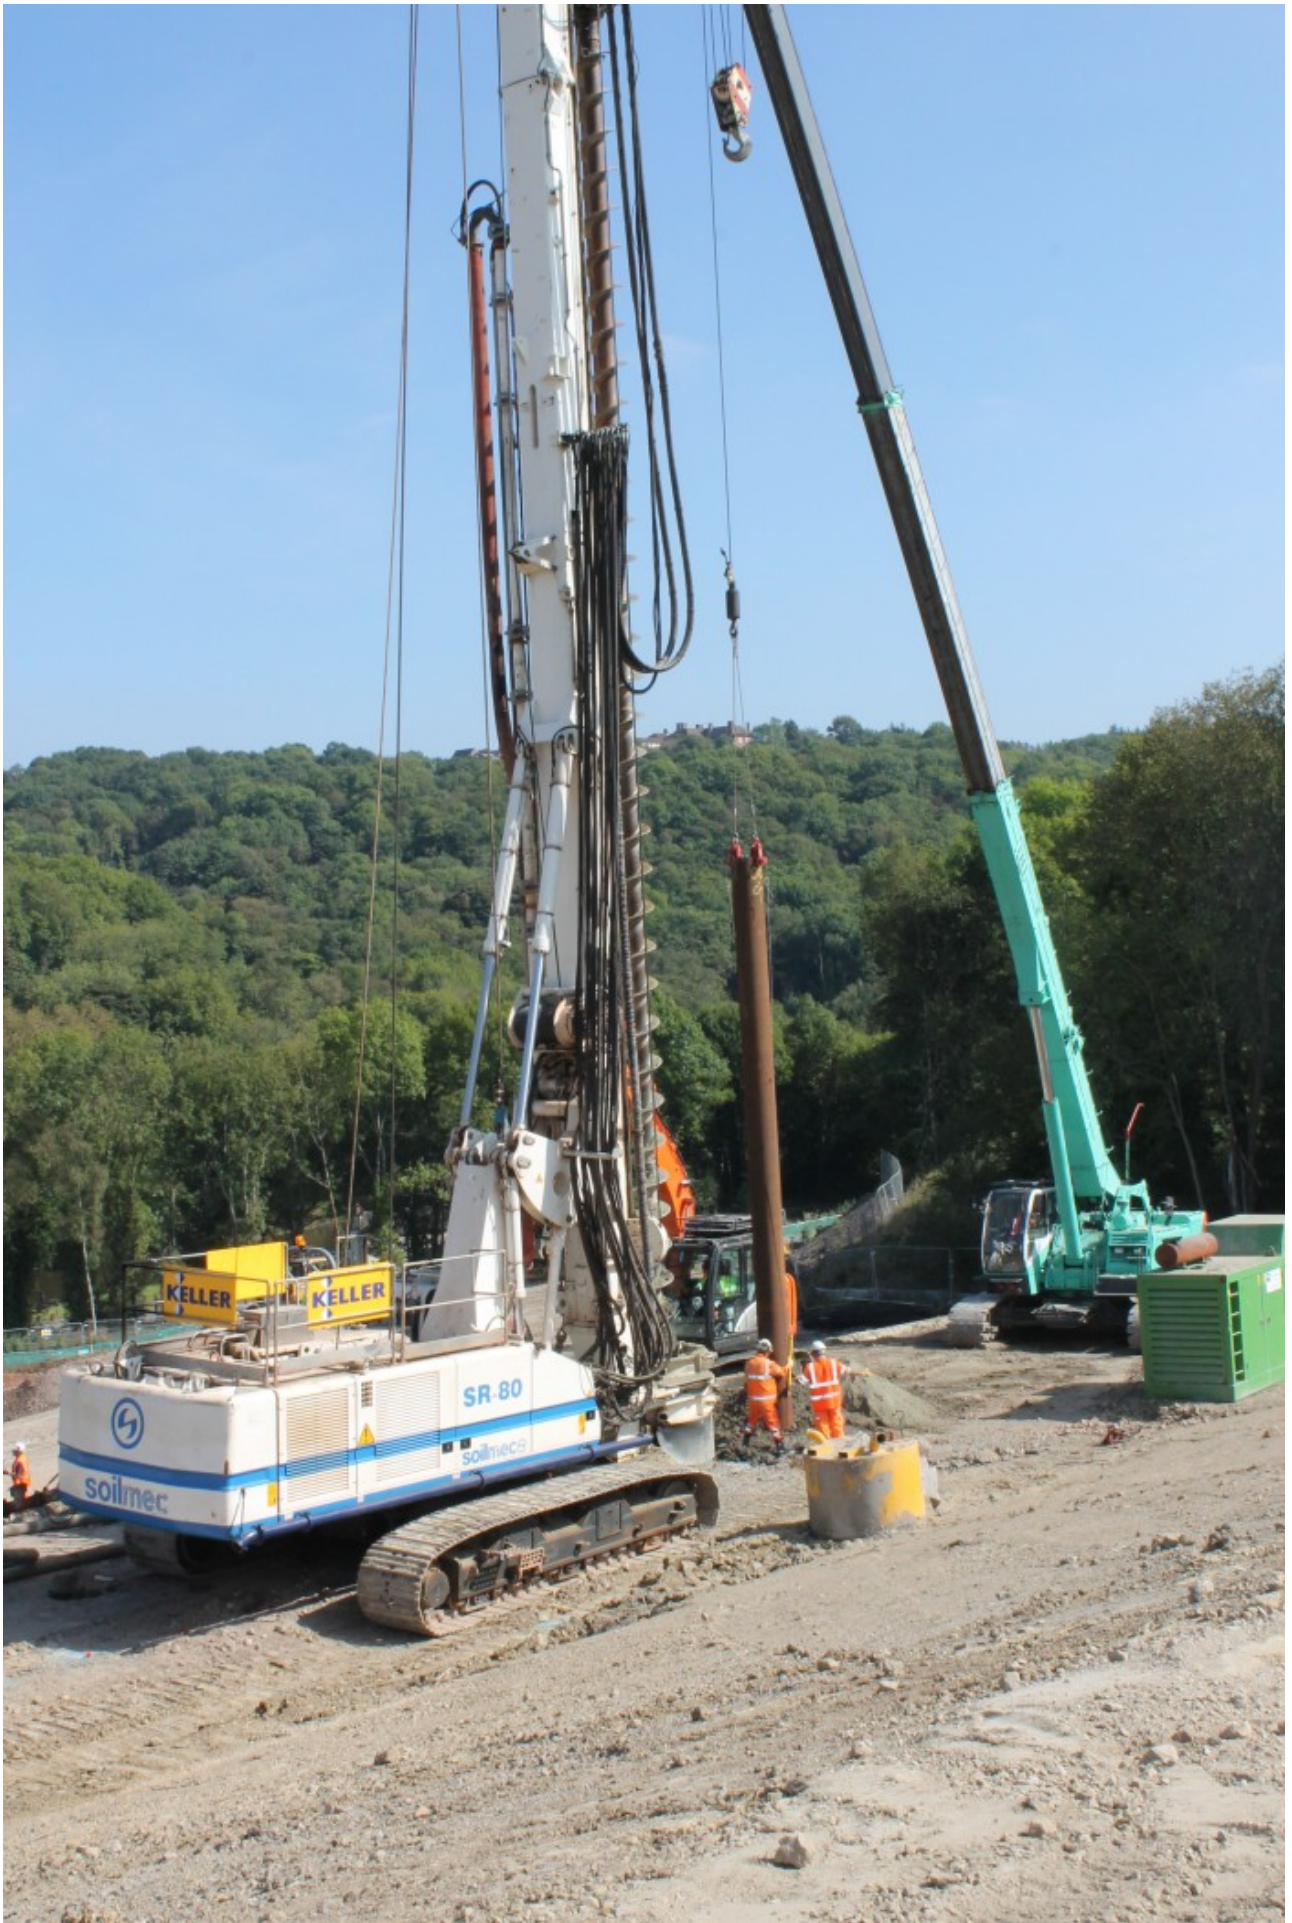
CFA piles were bored through tile and industrial waste and socketed into the underlying sandstone and mudstone bedrock in a series of rows extending up the valley sides. The 600mm diameter piles were reinforced with 457mm x 10mm CHS tube. Piles near to the river itself in a particularly unstable area of the slope were installed using lightweight Klemm rigs at a 350mm diameter

The main challenge was safely installing the 18m long piles using a heavy Soilmec SR80 rig which had the ability to bore into mudstone with the piling mat being carefully monitored for signs of movement by Getec, Keller's monitoring and instrumentation company. The sequence of work was carefully planned due to the high risk of ground movement.

A number of rows of very stiff piles were installed all the way down the slope to "pin" the active landslip detritus into the competent mudstone. In the most active areas, lighter rigs were used installing a number of smaller diameter piles. At the same time movement sensors were installed by Getec to detect any early signs of movement.
